TECHNICAL REPORT CERC-85-9

PROCEEDINGS OF THE FLOATING TIRE BREAKWATER WORKSHOP 8-9 NOVEMBER 1984

Coastal Engineering Research Center

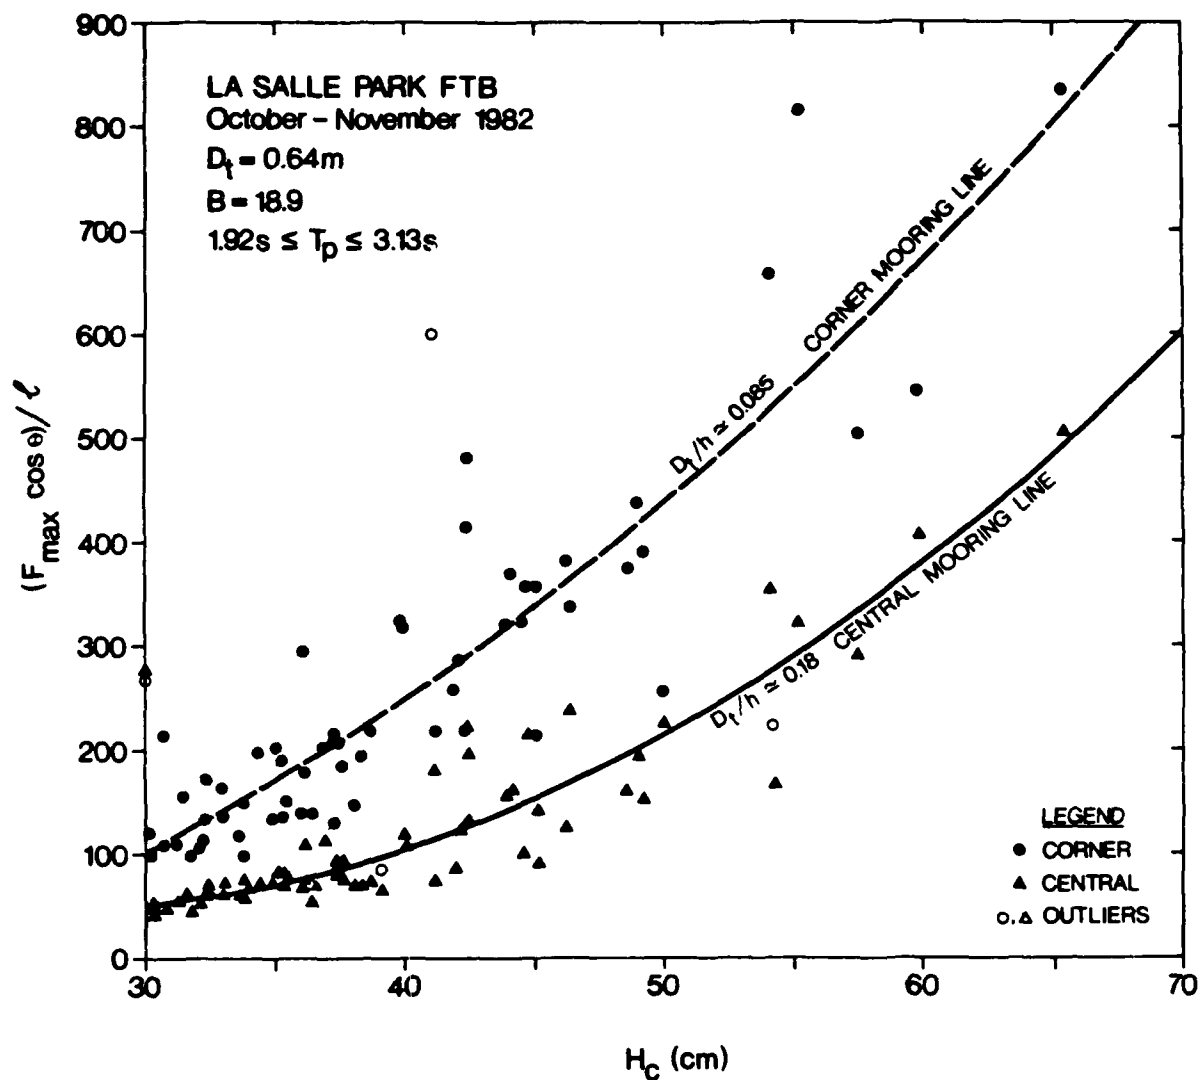
Figure 13. Dimensional plot of peak mooring load versus characteristic wave height data

After removing several outlying points from the data set, second-order regression curves were determined and are also shown in Figure 13.* Some of the scatter in results is probably due to L_p varying from 5.75 m to 15.2 m. However, there is insufficient data at overlapping values of H_c to determine a relation similar to that between F_d and L_p/D_t as done for Pipe-Tire floating breakwaters in Harms et al. (1981).

A striking feature of Figure 13 is that the mooring loads on the corner line ($D_t/h \approx 0.18$) are significantly greater than those at the central line ($D_t/h \approx 0.085$). Prototype-scale model tests of Pipe-Tire floating breakwaters (Harms and Westerink 1980) showed a large increase in mooring loads when D_t/h changed from 0.22 to 0.51. Prototype-scale model tests of Goodyear FTB's (Giles and Sorensen 1978) showed a slight decrease in mooring loads when D_t/h changed from 0.16 to 0.32. This latter trend, however, disagrees with the results of other model studies (Harms 1979) and with theoretical expectations. At La Salle Park, the increase in D_t/h from 0.085 to 0.18 is not expected to cause a large increase in mooring loads. A more likely reason for the increase in mooring loads from central to corner mooring lines is that waves diffract around the corner of the breakwater, essentially doubling the frontage restrained by the corner line. Clearly more data is needed on the influence of relative draft D_t/h on mooring forces. Meanwhile, for design purposes, it is suggested that the mooring load (in a direction perpendicular to the FTB length) of the corner line be estimated as twice the central mooring line load.

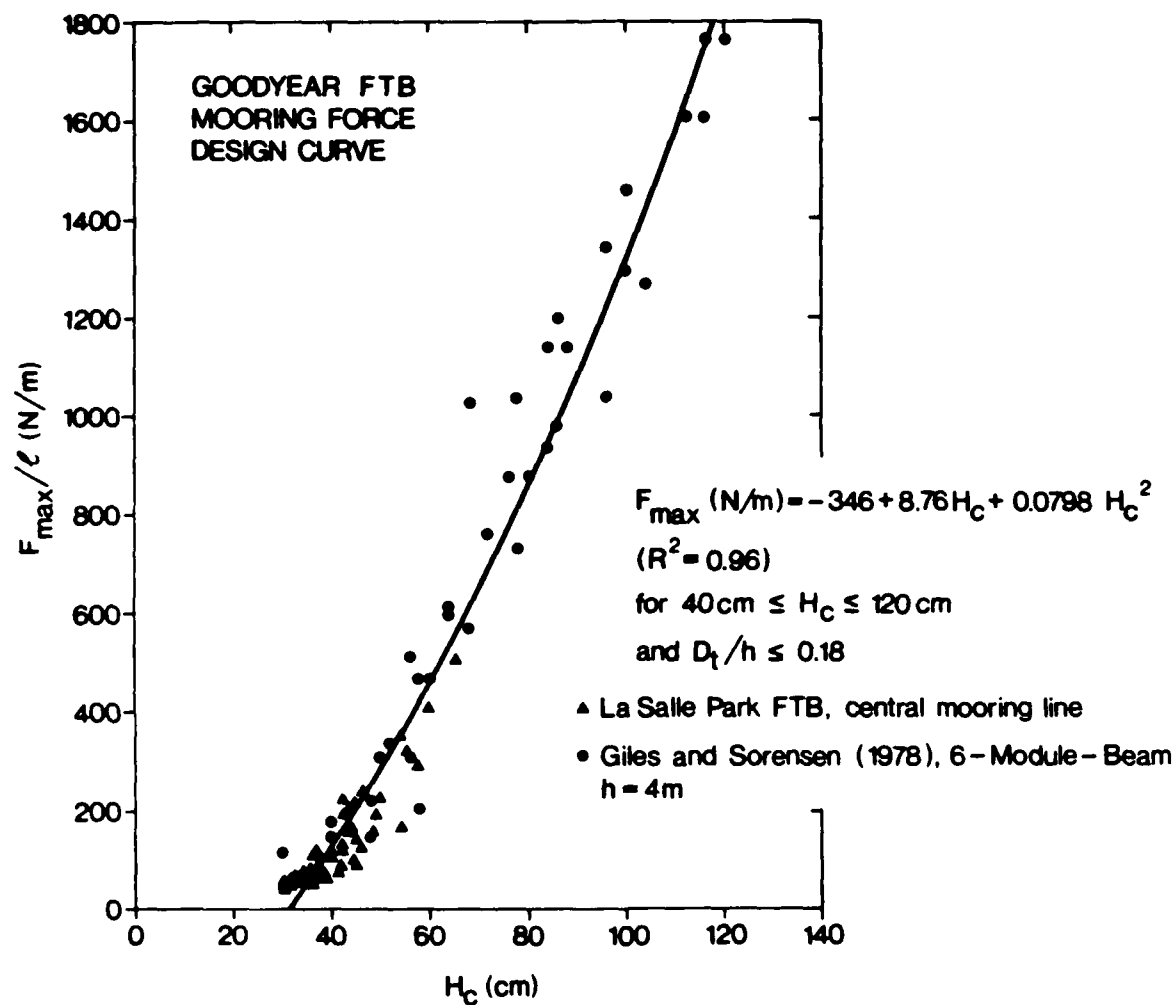
Results from the 6-module-beam two-dimensional prototype-scale tests by Giles and Sorensen (1978) in 4 m of water are compared with the La Salle Park results in Figure 14. For the Giles and Sorensen (1978) data, the height H of regular waves has been substituted for H_c . Agreement is surprisingly good. A second-order regression analysis of the 64 field test points and 39 model test points gives

Figure 14. La Salle Park peak mooring load data from central mooring line and 6-module-beam data from Giles and Sorensen (1978)

gauges. For the central anchor line the peak mooring loads per unit length were found to be in good agreement with those measured in earlier prototype-scale model tests (Figure 14). The peak loads measured on the corner anchor line were found to be significantly greater than those measured at the central anchor line.

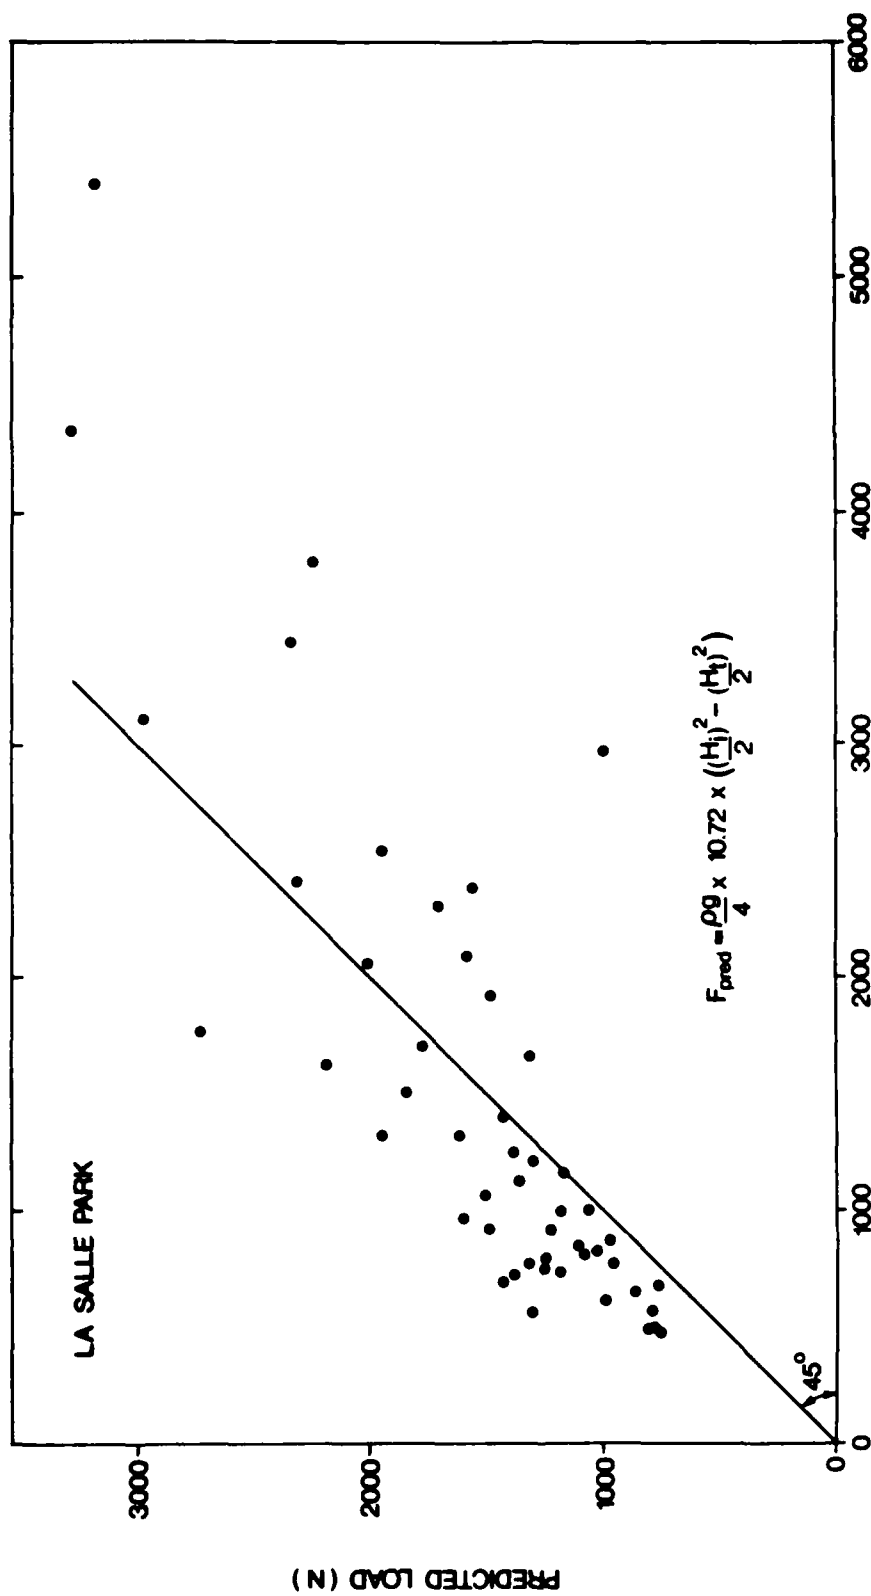
Figure 15. Comparison of measured peak mooring loads to predictions using relation of Lonquet-Higgins (1977)

frontage of 10.72 m) are compared to the peak loads measured at the central mooring line. Equation (9) tends to overpredict for loads less than 2000 N and to underpredict for larger loads. It should not be used for design purposes, contrary to some evidence presented in Galvin and Giles (1979) which gave $F = F_{\max}/2$. This lack of agreement can be attributed to the following reasons:
